SUBJECT: **Phase I Environmental Site Assessment Addendum**  
Warehouse Building  
925 Cornell Avenue & 950 Dartmouth Avenue  
Parcels 001-131-02 & 001-131-07  
Lovelock, Nevada

# Subsurface Investigation for Storage Tanks/Anomalies

**Converse Consultants**  
**Attn: Connor Welsh**  
**Site: 925 Cornell Ave**

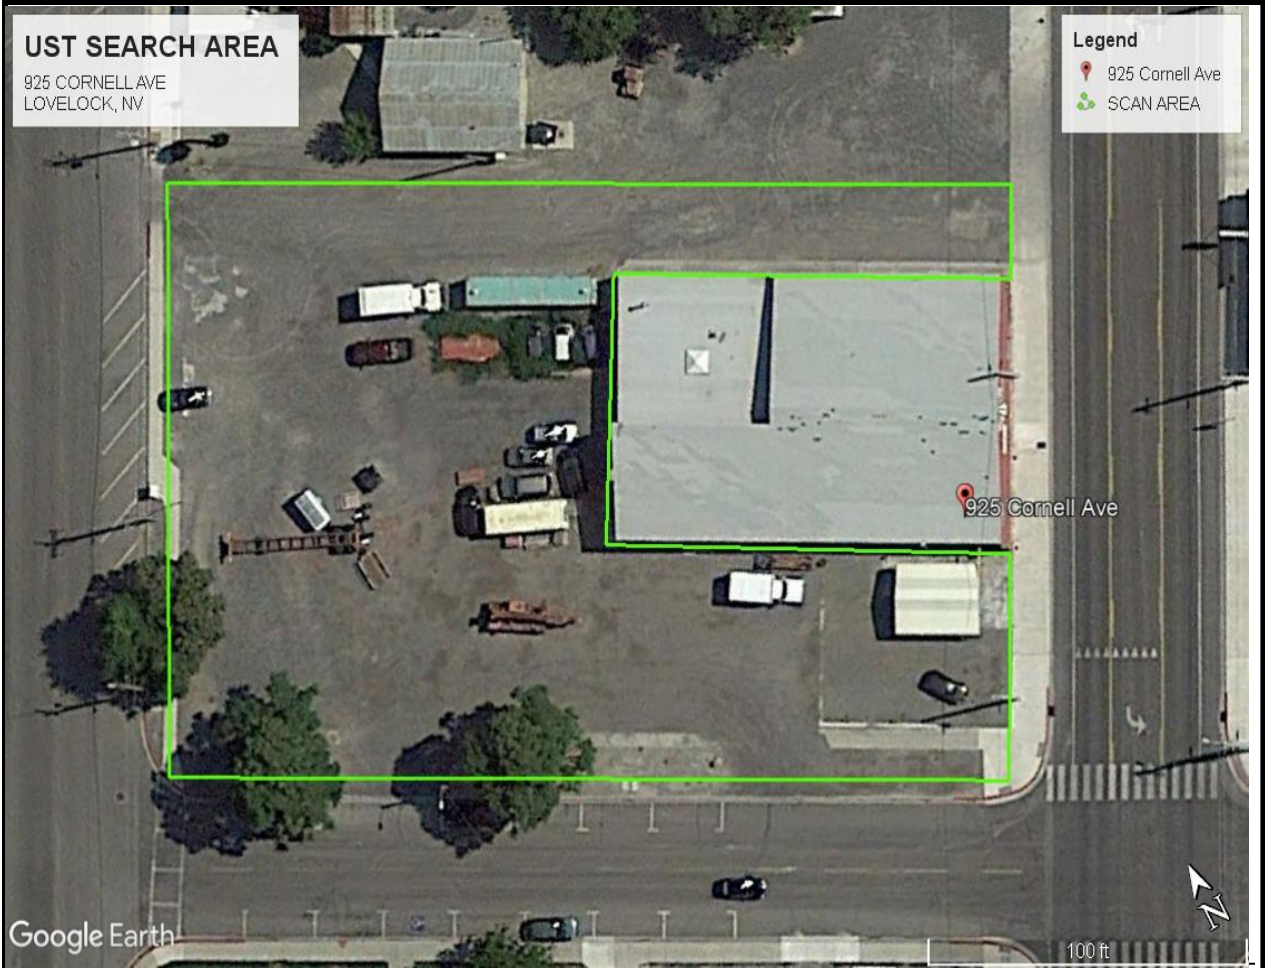
**UST SEARCH AREA**

925 CORNELL AVE  
LOVELOCK, NV

- 925 Cornell Ave
- SCAN AREA

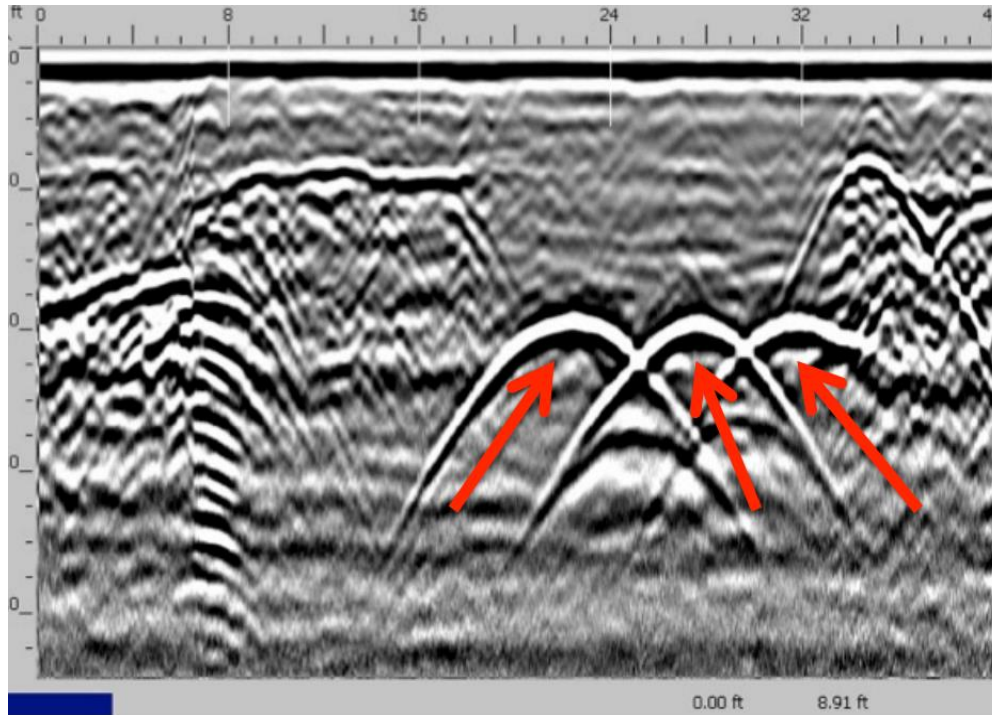
GPR DATA **SAMPLE ONLY**

THE ABOVE PHOTO IS A **SAMPLE** OF WHAT A UST MIGHT LOOK LIKE WHEN CAPTURED ON GPR DATA. WHEN COMPARED TO TODAY'S SCAN FROM YOUR SITE, WE CAN SEE THAT THE DATA DOES NOT RESEMBLE THE SAMPLE.

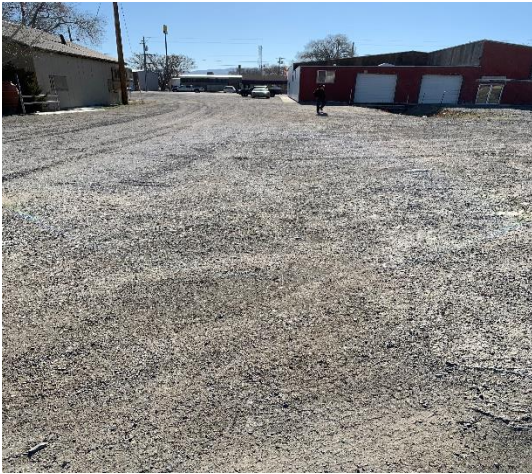
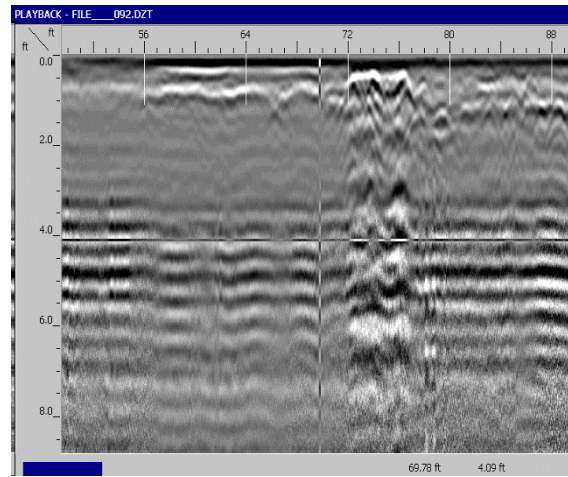
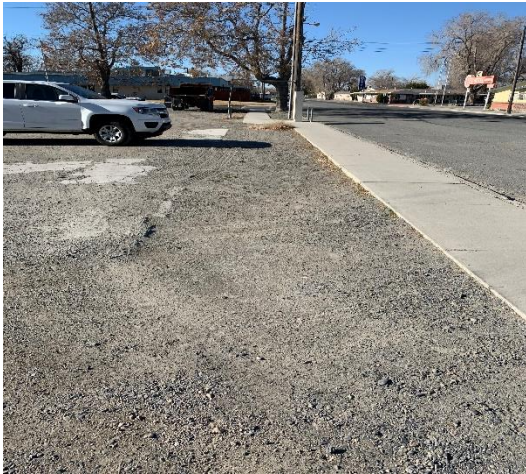
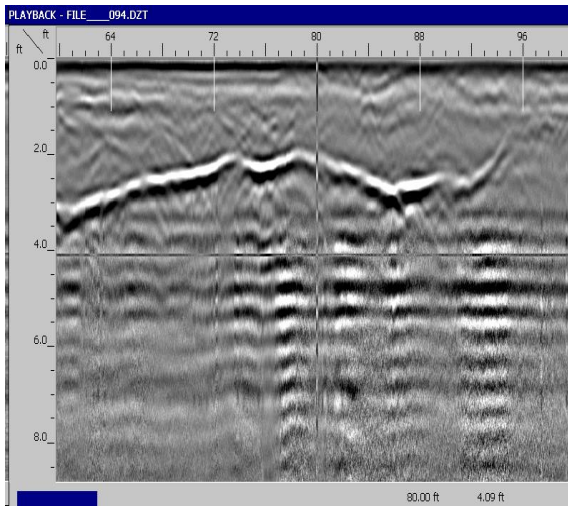
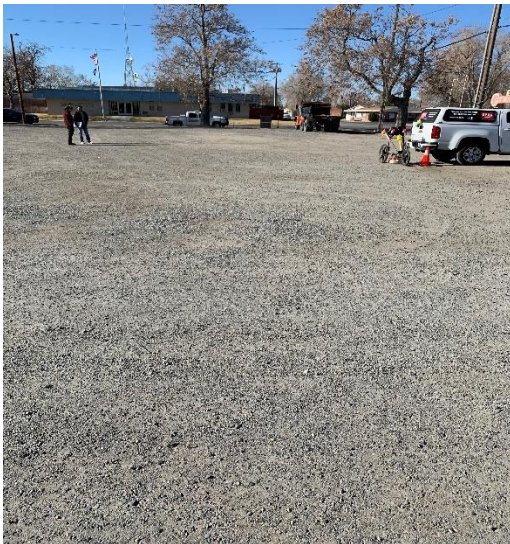
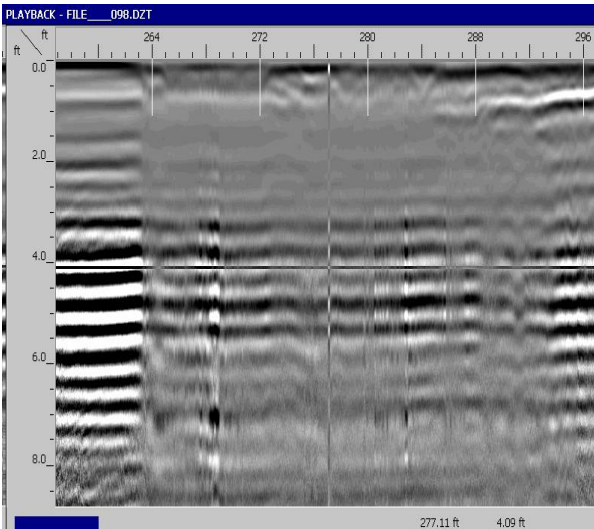
GPR Data Screenshots

We found that the soil allowed for maximum GPR depth penetration of 3 feet in most areas. Also, after completion of scans with GPR, there were no anomalies consistent with possible USTs detected in the scanning area.

IN THE FOLLOWING PAGES YOU WILL SEE SITE PHOTOS WITH CORRESPONDING DATA TAKEN USING GPR. WE CAN SEE THAT THERE IS NO DATA COLLECTED THAT SUGGESTS THE PRESENCE OF A UST(S).
