SUBJECT: **Phase I Environmental Site Assessment Addendum**  
Sierra Motel Property  
1380 Dartmouth Avenue  
Lovelock, Nevada

# Subsurface Investigation for Storage Tanks/Anomalies

**Site: 1380 Dartmouth AVE**

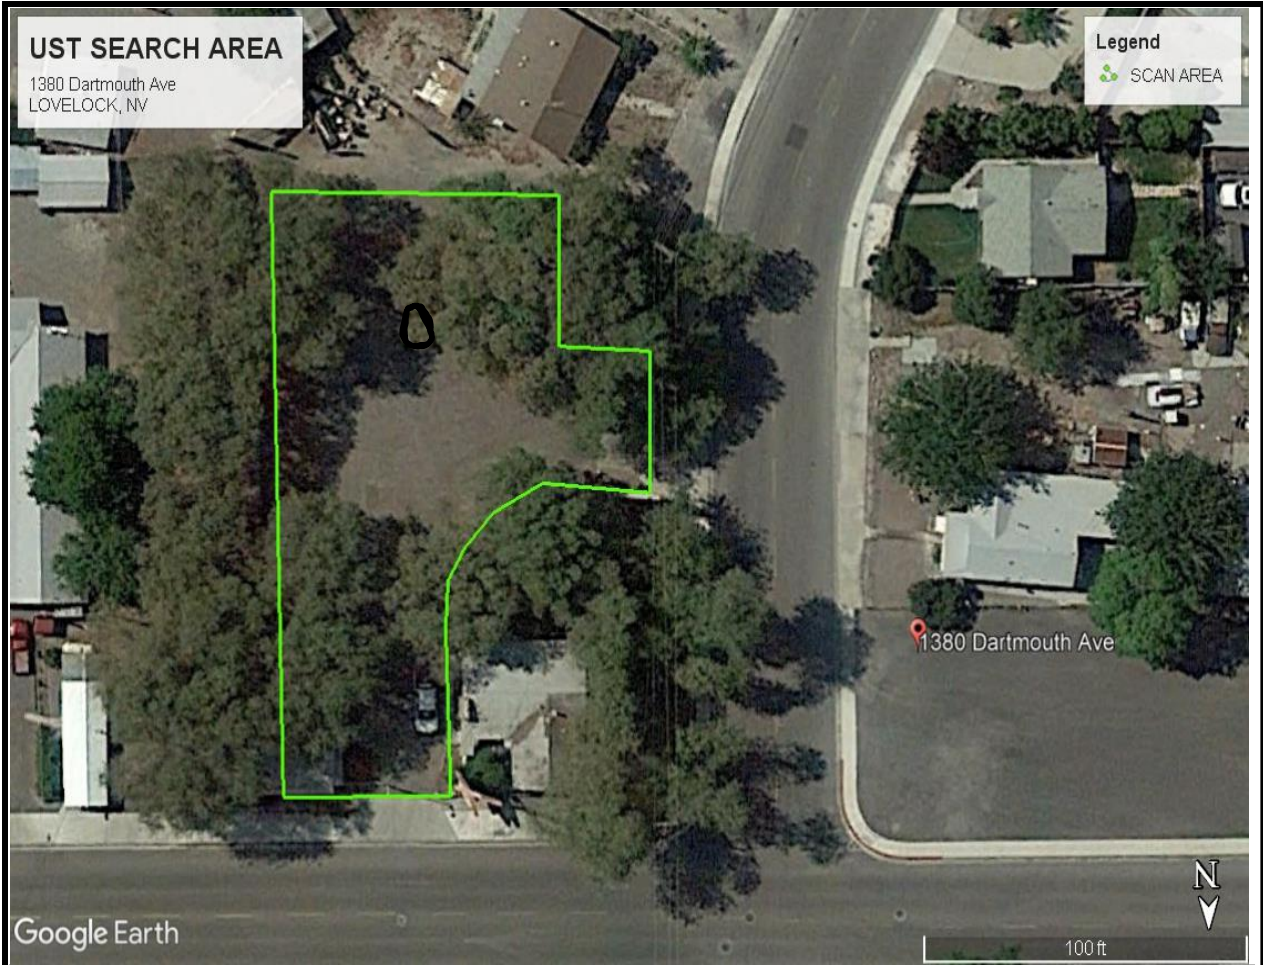
**UST SEARCH AREA**

We found that the soil allowed for maximum GPR depth penetration of 3 feet in most areas. Also, after completion of scans with GPR, there were no anomalies consistent with possible USTs detected in the scanning area.

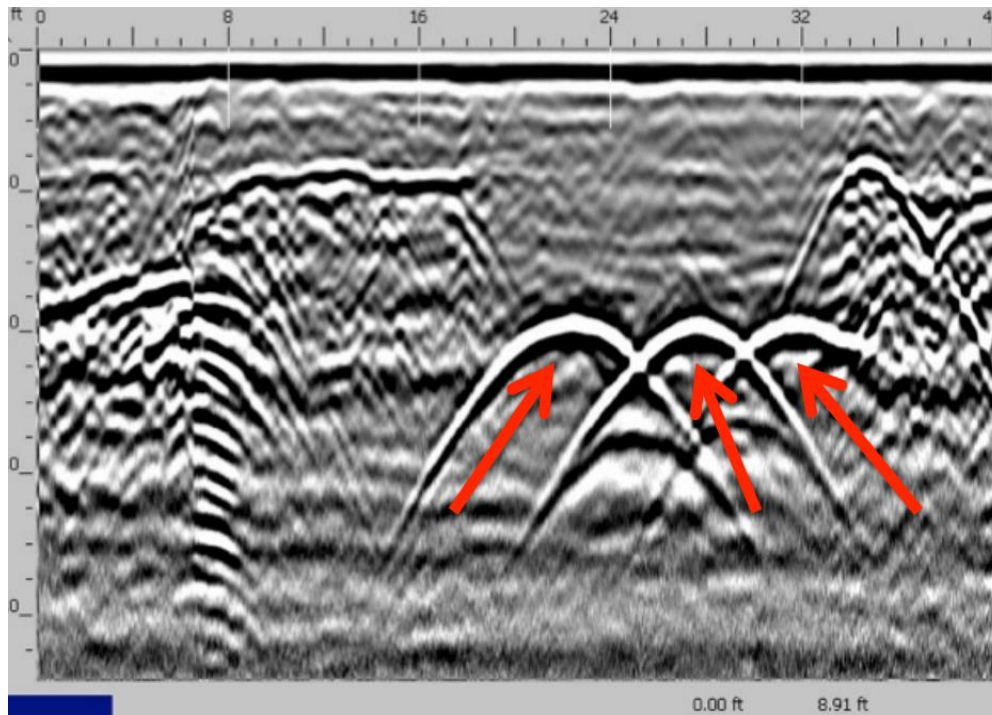
GPR DATA **SAMPLE ONLY**

THE ABOVE PHOTO IS A **SAMPLE** OF WHAT A UST MIGHT LOOK LIKE WHEN CAPTURED ON GPR DATA. WHEN COMPARED TO TODAY'S SCAN FROM YOUR SITE, WE CAN SEE THAT THE DATA DOES NOT RESEMBLE THE SAMPLE.

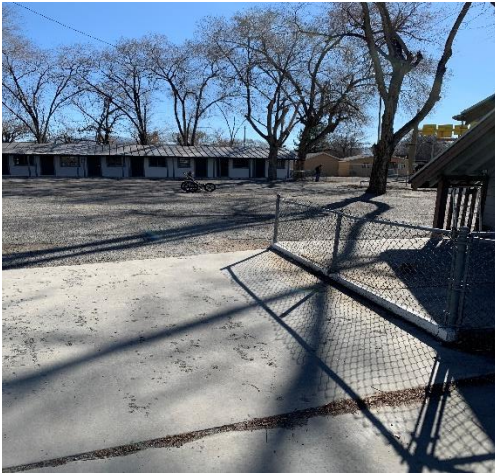
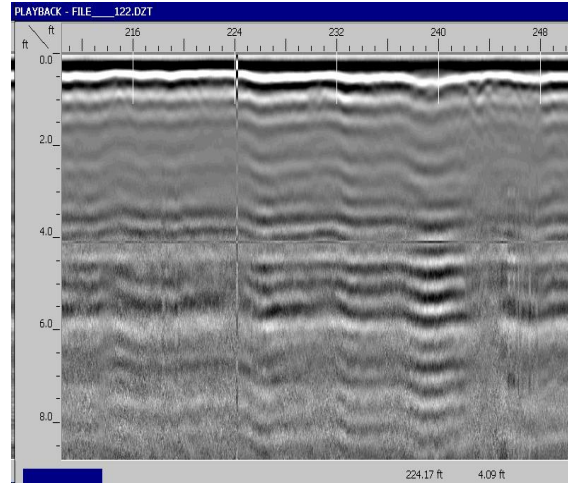
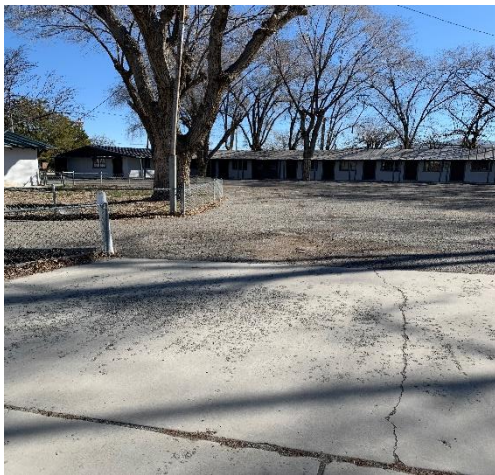
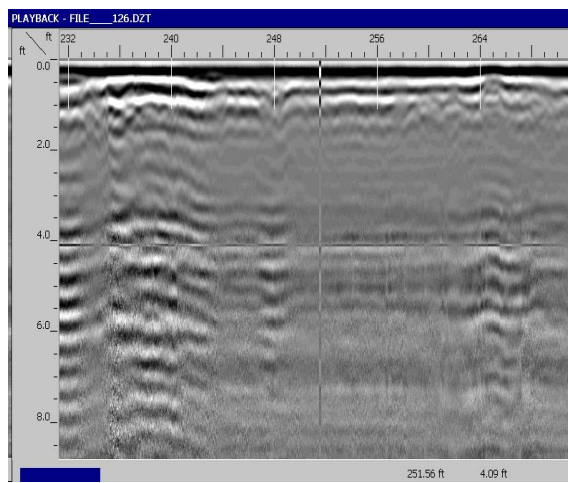
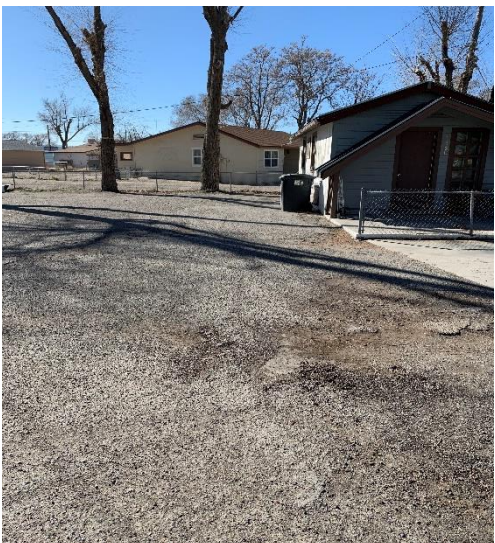
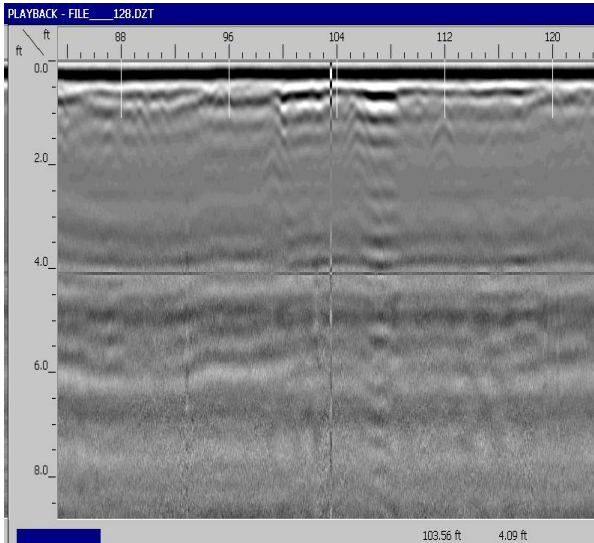
GPR Data Screenshots

IN THE FOLLOWING PAGES YOU WILL SEE SITE PHOTOS WITH CORRESPONDING DATA TAKEN USING GPR. WE CAN SEE THAT THERE IS NO DATA COLLECTED THAT SUGGESTS THE PRESENCE OF A UST(S).

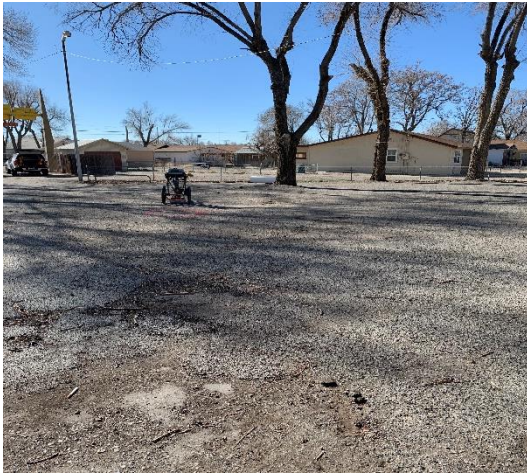
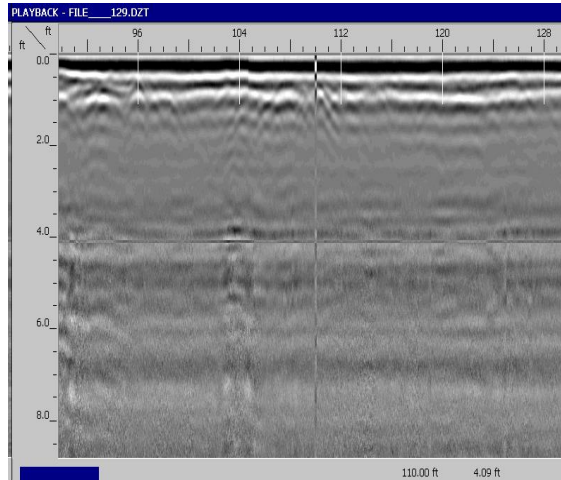
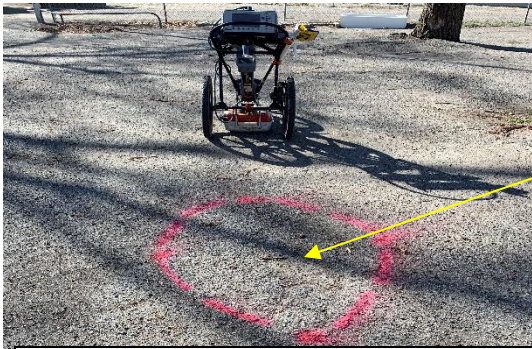
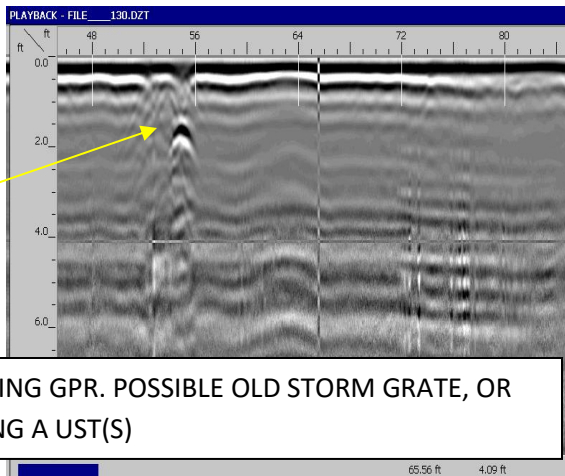
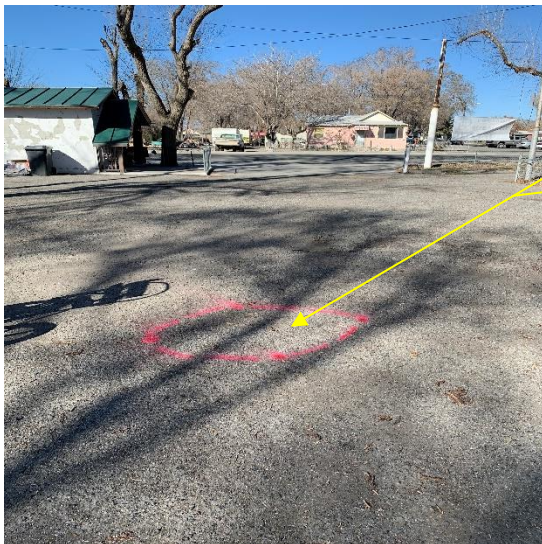
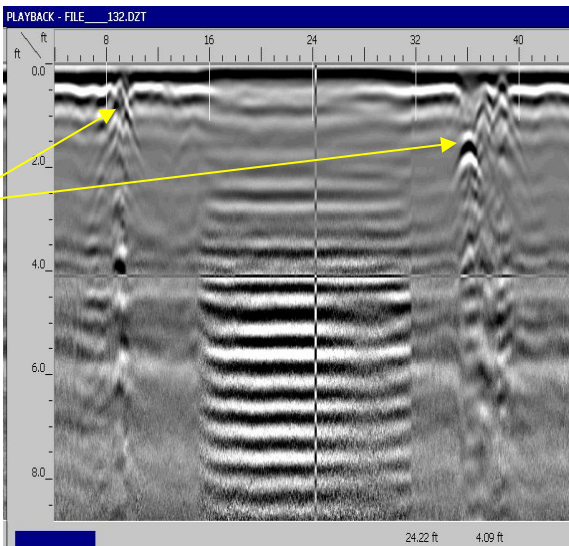
THIS PINK OUTLINED AREA WAS FOUND USING GPR. POSSIBLE OLD STORM GRATE, OR LID. WE DON'T SEE ANY SIGNS OF THIS BEING A UST(S)
